**What Happened:** On July 18<sup>th</sup>, 2014, a worker walking from a parking lot to a control room stepped on a 'cable-hole' cover. When the worker stepped on the cover, it shifted, and the worker's leg partially went into the hole, scraping his shin which required medical treatment.

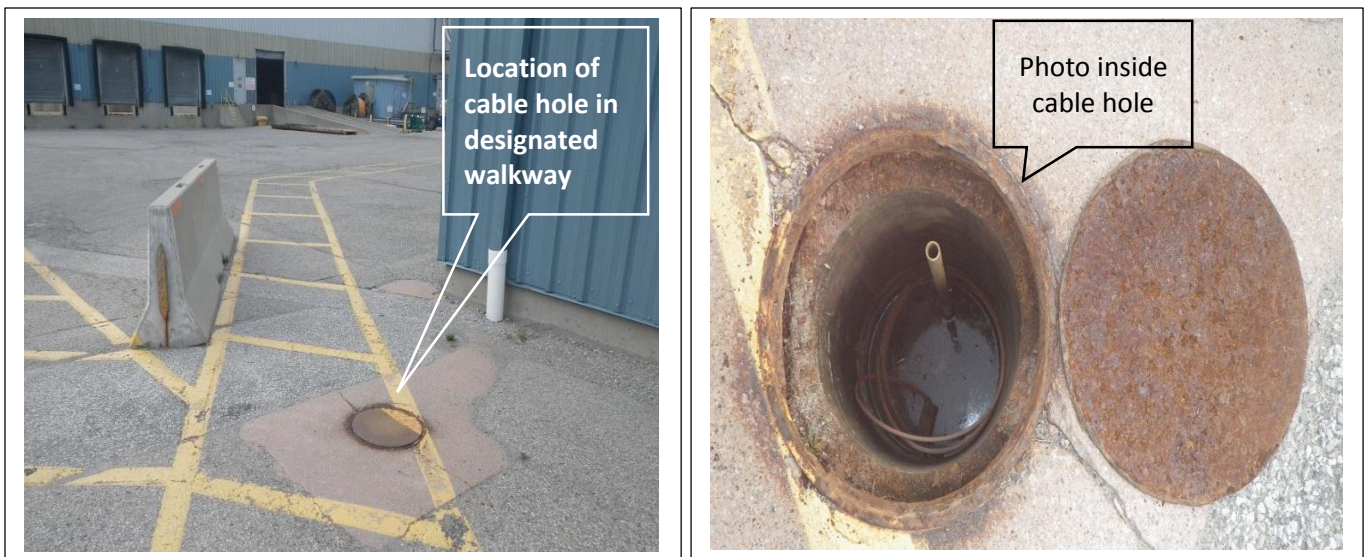
- Location of cable hole cover was in a designated walkway
- The investigation has started and severe corrosion has been noted on both the cover and the supporting ring

- The investigation team actions include evaluating other covers across the site to determine mitigations/ controls that are required
- Reinforces the importance of using risk assessment tools to **ASSESS**, **ANALYZE** and **ACT** for all tasks that we perform:
  - Avoid (where possible) walking on covers
  - Inform area owners of any covers that appear to have stability/ excess corrosion concerns
